**Flood Control Project Maintenance
Levee Inspections**

Fall 2013 Levee Maintenance Deficiency Summary Report

Sutter Maintenance Yard East Levee Sutter Bypass

Levee Inspection Report By Mile - Fall 2013

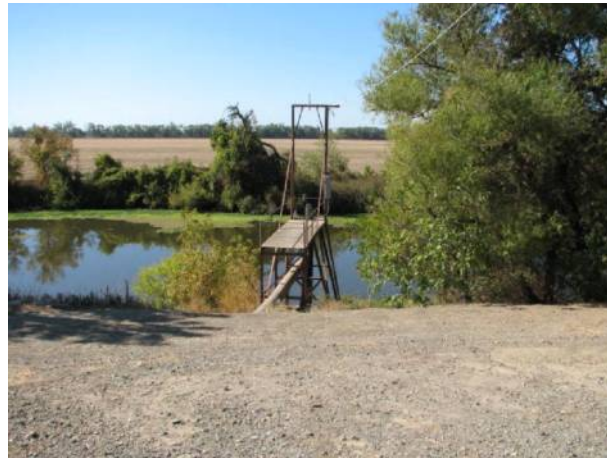
Levee Mile Report Line	6
Start Levee Mile	1.13
End Levee Mile	1.13
Location	Land Side
Category	Supplemental
Item	DWR UCIP Field Study

Pump on metal pier on WS slope.

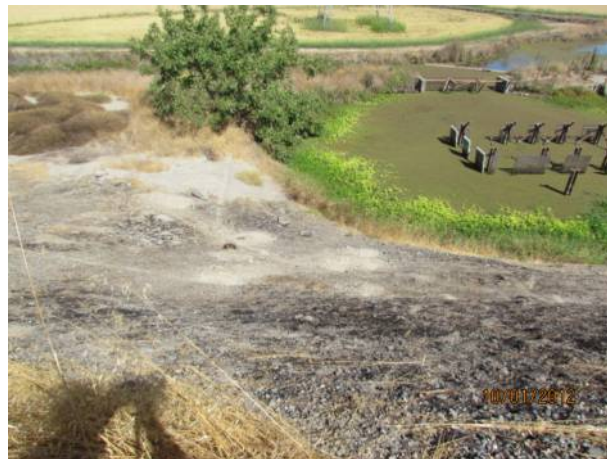
Levee Mile Report Line	7
Start Levee Mile	3.60
End Levee Mile	3.60
Location	Land Side
Category	Earthen Levee
Item	Animal Control

7	3.60	3.60	Earthen Levee	Animal Control	LS	M	A3 : No rodents visible, but rodent burrows visible; need to backfill and compact or grout burrows.	39.120422 ° -121.779907 °	39.120422 ° -121.779907 °	7 Y
DWR ID: DWR_ST0002_01_f_2012_7

View of rodent activity along landside slope.

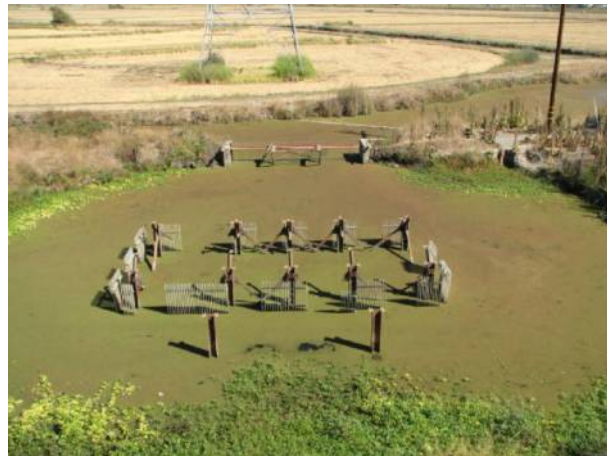
Levee Mile Report Line	9
Start Levee Mile	3.61
End Levee Mile	3.61
Location	Land Side
Category	Supplemental
Item	DWR UCIP Field Study

9	3.61	3.61	Supplemental	DWR UCIP Field Study	LS	M	Inspector Comments: FS_ID:13742 EP_NO: N/A Repair Type: Non-Urgent Crossing Status: Found UCIP Comments: Flap gates left in open position. Unable to determine type of abandonment for concrete culverts. Contact inspector to determine type of abandonment. 5/22/2013 Concrete culvert is being used as gravity drain for LS ditch. FIELD_STRUCT_DESC: 1 of 2. 4-foot by 6-foot concrete box culvert through the levee, 30.0 feet below the crown. Slide gate in concrete well on the landward shoulder. Wood flap gate and concrete headwall on the waterward end. Abandoned State pumping plant on the landward side. Originally installed under O+M. FS Date: 5/24/2013 10:06:10 AM	39.120372 ° -121.779800 °	39.120372 ° -121.779800 °	332 Y
DWR ID: DWR_ST0002_01_f_2013_332

Abandoned pumphouse and sump on LS toe.

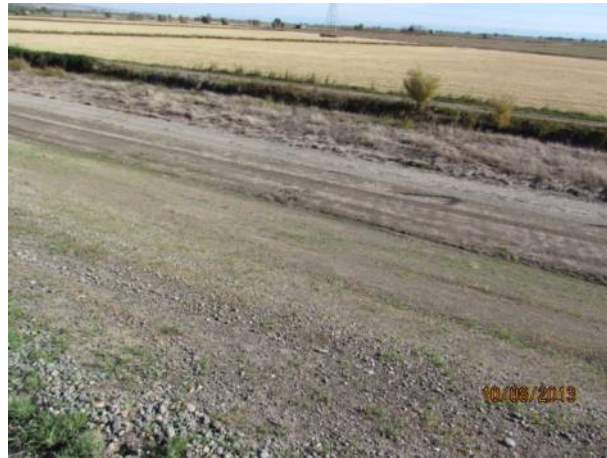
Levee Mile Report Line	12
Start Levee Mile	4.97
End Levee Mile	4.99
Location	Land Side
Category	Earthen Levee
Item	Animal Control

12	4.97	4.99	Earthen Levee	Animal Control	LS	A Ma	A1 : Exterminate rodents and backfill and compact or grout burrows.	39.107193 ° -121.761777 °	39.106848 ° -121.761472 °	8 Y
----	------	------	---------------	----------------	----	---------	---	------------------------------	------------------------------	--------

View of the grouted rodent holes.

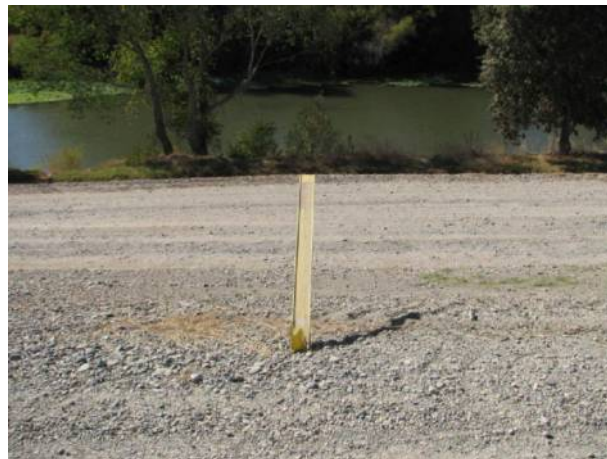
Levee Mile Report Line	15
Start Levee Mile	10.44
End Levee Mile	10.44
Location	Land Side
Category	Supplemental
Item	DWR UCIP Field Study

LMR No.	Levee Mile		Category	Item	Location * + Rating	Action/Comment	GPS Latitude/Longitude		Issue No. Photo
	Start	End					Start	End	
15	10.44	10.44	Supplemental	DWR UCIP Field Study	WS M En	Inspector Comments: FS_ID:13763 EP_NO: 14455 Repair Type: Non-Urgent Crossing Status: Indicator Found UCIP Comments: 5/22/2013 Carsonite marker on WS shoulder is broken and should be replaced. FIELD_STRUCT_DESC: 3 of 3. 4.5-inch Natural gas pipelines through the levee installed 2 feet below the crown. Pipes were paced in same trench 1-foot apart. Gasline markers on LS toe and WS shoulder. Design drawings available in the permit. FS Date: 5/22/2013	39.033517 ° -121.728925 °	39.033517 ° -121.728925 °	337 Y
DWR ID: DWR_ST0002_01_f_2013_337									
16	10.89	10.92	Supplemental	USACE Erosion Survey	WS M Ma	Inspector Comments: 2011 - Small section of the mid levee slope has eroded from wind wave. 2012: Site is part of the extended inventory, last inspected 2011. [2012 Site ID: SBP_11-1_L]	39.024835 ° -121.726929 °	39.024399 ° -121.726808 °	1

Gasline markers on WS shoulder.

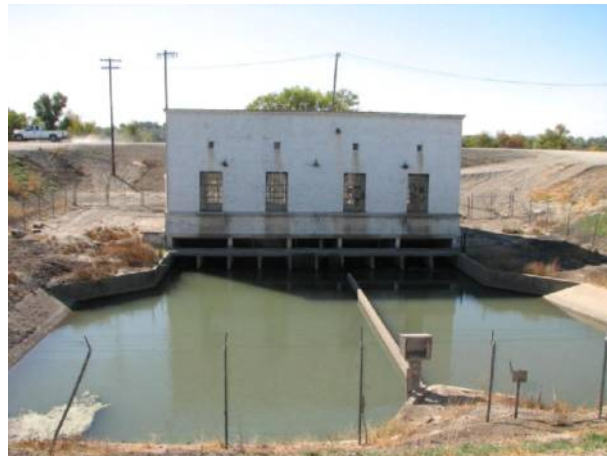
Levee Mile Report Line	18
Start Levee Mile	11.00
End Levee Mile	11.00
Location	Land Side
Category	Supplemental
Item	DWR UCIP Field Study

Pumping plant on LS toe.

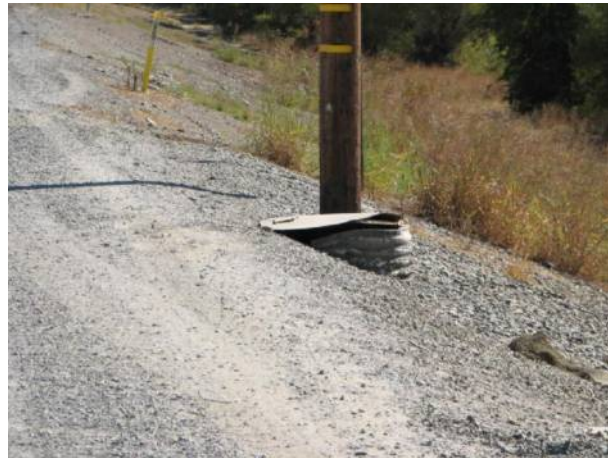
Levee Mile Report Line	27
Start Levee Mile	11.01
End Levee Mile	11.01
Location	Land Side
Category	Supplemental
Item	DWR UCIP Field Study

DWR ID: DWR_ST0002_01_f_2013_347										
27	11.01	11.01	Supplemental	DWR UCIP Field Study	WS	M En	Inspector Comments: FS_ID:13777 EP_NO: 3165 Repair Type: Non-Urgent Crossing Status: Found UCIP Comments: Need to determine type of abandonment. 5/22/2013 Same as last inspection. FIELD_STRUCT_DESC: 10-inch drainage pipe through the levee, 2.0 feet below the crown. Siphon breaker in a 36-inch CM pipe riser on the waterward shoulder. Flap gate on the waterward end. (App. 3165 - DWR). Minimalistic design drawings available. FS Date: 5/22/2013	39.025560 ° -121.726846 °	39.025560 ° -121.726846 °	348 Y
DWR ID: DWR_ST0002_01_f_2013_348										
28	13.13	13.13	Supplemental	DWR UCIP Field Study	WS	M En	Inspector Comments: FS_ID:6580 EP_NO: 15571 Repair Type: Non-Urgent Crossing Status: Not Found UCIP Comments: Need to determine status of pipeline. Unable to locate any markers in field. FIELD_STRUCT_DESC: 10.75-IN. STEEL GAS PIPELINE 2 feet below the levee crown. Permit #15571. Design drawings are available. FS Date: 10/9/2012 2:57:38 PM	38.996304 ° -121.716290 °	38.996304 ° -121.716290 °	349

Siphon breaker in 36-inch CMP riser on WS shoulder. Pipe visible at siphon breaker.

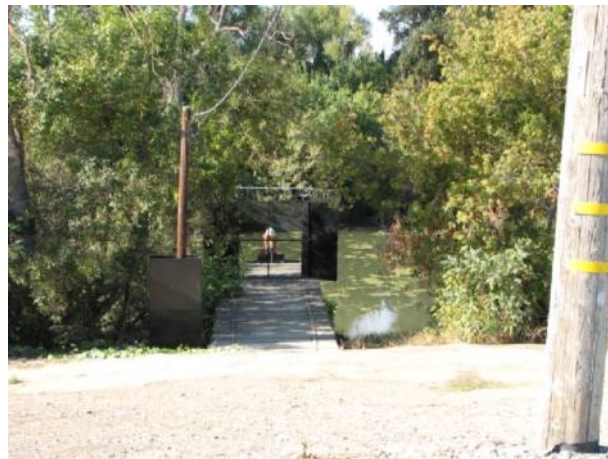
Levee Mile Report Line	31
Start Levee Mile	13.54
End Levee Mile	13.54
Location	Land Side
Category	Supplemental
Item	DWR UCIP Field Study

31	13.54	13.54	Supplemental	DWR UCIP Field Study	WS M En	Inspector Comments: FS_ID:6600 EP_NO: N/A Repair Type: Non-Urgent Crossing Status: Found UCIP Comments: Verify work (if any) was done to replace original equipment with inspector. FIELD_STRUCT_DESC: 18-inch pipe through the levee, 5.5 feet below the crown. Pipe measures 16-inches at pump and on LS outlet. Siphon breaker in a 16-inch corrugated metal pipe riser on the landward slope. Pump on pile structure in the channel. Meter and pole on the bank. Originally included in O+M manual. FS Date: 10/9/2012 2:58:47 PM	38.991808 ° -121.711512 °	38.991808 ° -121.711512 °	352 Y
----	-------	-------	--------------	-------------------------	------------	---	------------------------------	------------------------------	----------

Pump on Pier on WS toe.

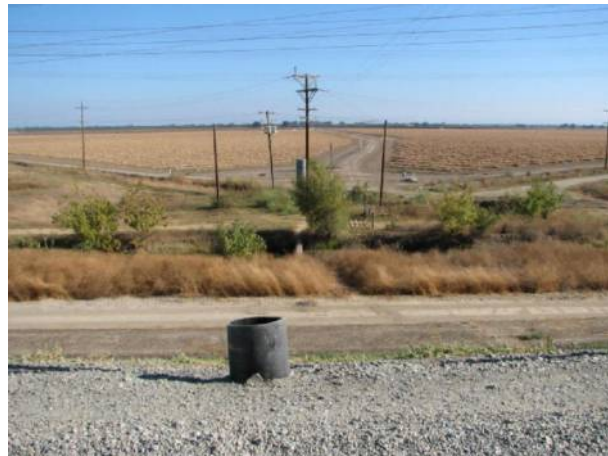
Levee Mile Report Line	33
Start Levee Mile	14.70
End Levee Mile	14.70
Location	Land Side
Category	Supplemental
Item	DWR UCIP Field Study

Siphon breaker in PVC standpipe on LS shoulder and Concrete riser in adjacent field.

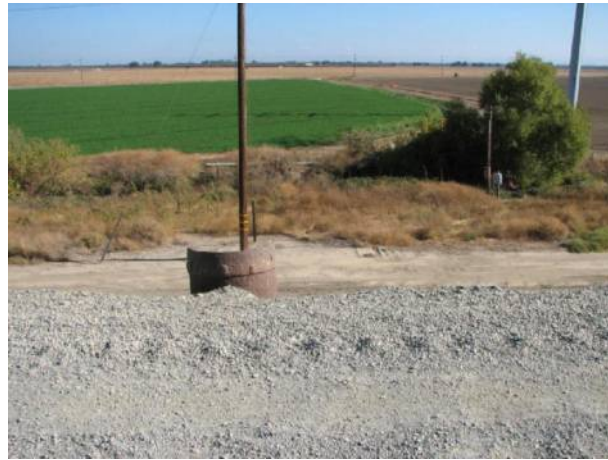
Levee Mile Report Line	35
Start Levee Mile	14.91
End Levee Mile	14.91
Location	Land Side
Category	Supplemental
Item	DWR UCIP Field Study

LMR No.	Levee Mile		Category	Item	Location	Rating	Action/Comment	GPS Latitude/Longitude		Issue No.
	Start	End						Start	End	
35	14.91	14.91	Supplemental	DWR UCIP Field Study	LS	M En	Inspector Comments: FS_ID:13784 EP_NO: N/A Repair Type: Non-Urgent Crossing Status: Found UCIP Comments: Pipe has not been abandoned properly. It should be removed from the levee section.5/23/2013 Same as last inspection. FIELD_STRUCT_DESC: 16-inch steel pipe through the levee, 3.5 feet below the crown. Siphon breakers in 30-inch steel risers on both WS and LS shoulders. Vertical pump on pile structure in stream (removed). FS Date: 5/23/2013	38.979377 ° -121.691929 °	38.979377 ° -121.691929 °	356 Y
DWR ID: DWR_ST0002_01_f_2013_356										
36	16.40	16.40	Earthen Levee	Animal Control	LS	C En	A1 : Exterminate rodents and backfill and compact or grout burrows.	38.965675 ° -121.670967 °	38.965675 ° -121.670967 °	325

Steel riser on LS shoulder.

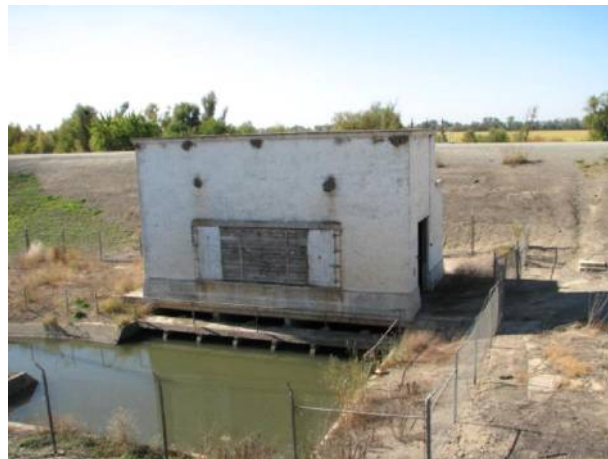
Levee Mile Report Line	37
Start Levee Mile	19.45
End Levee Mile	19.45
Location	Land Side
Category	Supplemental
Item	DWR UCIP Field Study

DWR ID: DWR_ST0002_01_s_2012_325										
37	19.45	19.45	Supplemental	DWR UCIP Field Study	LS	M En	Inspector Comments: FS_ID:6615 EP_NO: N/A Repair Type: Non-Urgent Crossing Status: Found UCIP Comments: Determine type of abandonment for concrete culvert. FIELD_STRUCT_DESC: 1 of 3. 4-foot by 6-foot concrete box culvert through the levee, 26.0 feet below the crown. Slide gates in a concrete well on the waterward shoulder. Wooden flap gates and concrete headwall on the waterward end. Concrete steps and staff gage reading to 53.0 feet on the waterward slope. Originally included in O+M manual. FS Date: 10/9/2012 3:28:00 PM	38.932476 ° -121.635173 °	38.932476 ° -121.635173 °	357 Y
DWR ID: DWR_ST0002_01_f_2013_357										
38	19.45	19.45	Supplemental	DWR UCIP Field Study	LS	M En	Inspector Comments: FS_ID:6612 EP_NO: N/A Repair Type: Non-Urgent Crossing Status: Found UCIP Comments: Determine type of abandonment for concrete culvert. FIELD_STRUCT_DESC: 1 of 3. 4-foot by 6-foot concrete box culvert through the levee, 26.0 feet below the crown. Slide gates in a concrete well on the waterward shoulder. Wooden flap gates and concrete headwall on the waterward end. Concrete steps and staff gage reading to 53.0 feet on the waterward slope. Originally included in O+M manual. FS Date: 10/9/2012 3:28:00 PM	38.932510 ° -121.635174 °	38.932510 ° -121.635174 °	358

Pumphouse on LS toe.

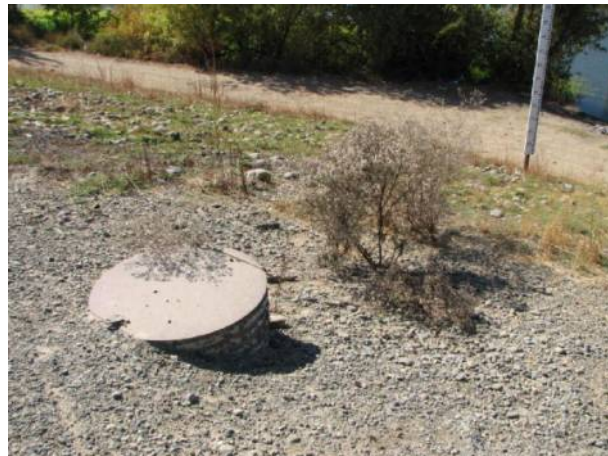
Levee Mile Report Line	43
Start Levee Mile	19.46
End Levee Mile	19.46
Location	Land Side
Category	Supplemental
Item	DWR UCIP Field Study

36-inch CMP riser on WS shoulder.

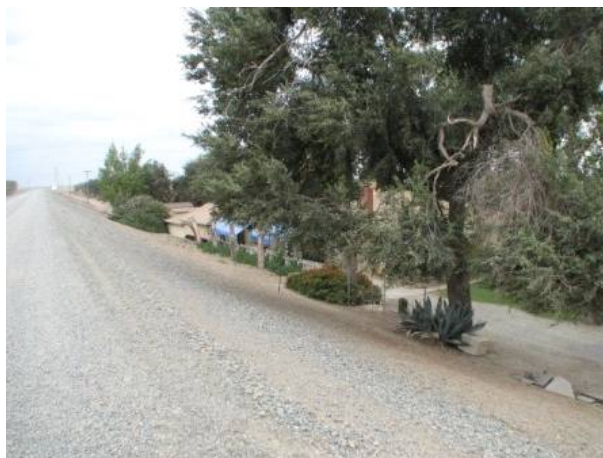
Levee Mile Report Line	45
Start Levee Mile	20.64
End Levee Mile	20.64
Location	Land Side
Category	Earthen Levee
Item	Encroachments

View of the building next to the landside toe of the levee.

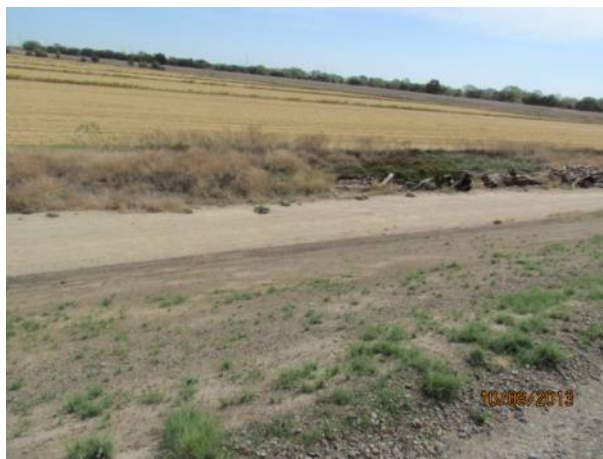
Levee Mile Report Line	46
Start Levee Mile	20.91
End Levee Mile	20.91
Location	Land Side
Category	Earthen Levee
Item	Animal Control

View of the grouted rodent holes.
